SC No Polish Connector

New Product Introduction

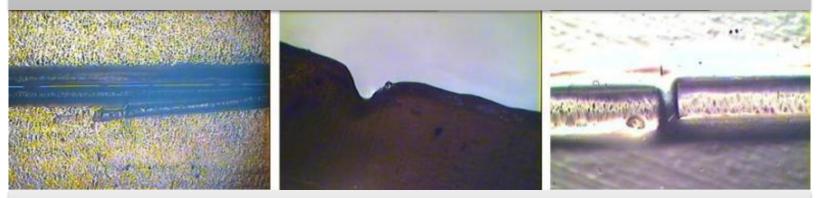
Below pictures shows v-groove condition under a 200x microscope.

From the pictures, we could see clearly that v-groove deforms obviously, which lead to fiber mis-alignment and will create high optical loss.

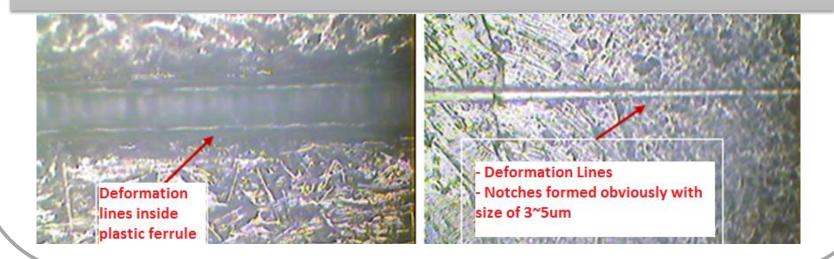
Ceramic has distinctive rigidity -- Non-deformed interconnection point

- For V-groove plastic ferrule, fiber is locked and forced by unnecessary pressure, which causes deformation of fiber in long run.
- Ceramic ferrule can provide superior bending strength than those of plastic ferrules.
- The innovative C-slot design on ceramic ferrule allows fiber interconnection inside the ferrule hole without giving unnecessary pressure.
- Thus, assure the interconnection point is non-deformed.

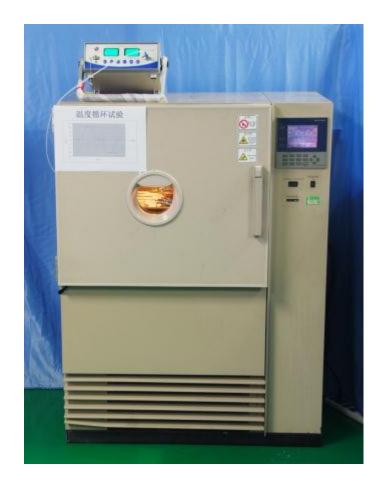
2. Result of Particular Test (a)

High-Low Temperature Cycle Test

- Max High Temperature : Ta = +85 °C
- Max Low Temperature : Tb = -40 °C
- Cycles : 21 cycles (8hrs/cycle), 168 hrs in total

• IR : ≤0.3dB, RL : ≤5dB

- IR : ≤0.05dB, RL : ≤1.5dB
- No mechanical damage, deformation cracking or relaxing

• IL : ≤2dB, RL : ≤0.1dB

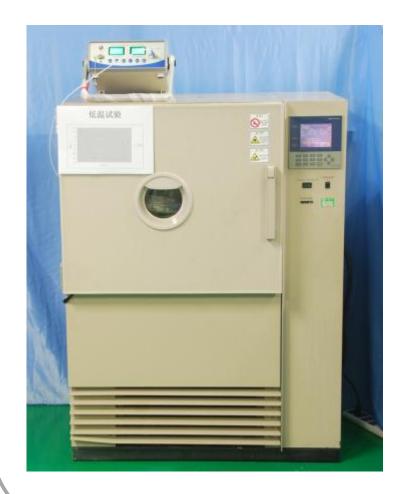
2. Result of Particular Test (b)

Low Temperature Test

- Temperature : -40 °C
- Duration : 96h

• IL : ≤0.3dB, RL : ≤5dB

- IL : ≤0.04dB, RL : ≤1.7dB
- No mechanical damage, deformation cracking or relaxing

• IL : ≤0.1dB, RL : ≤2dB

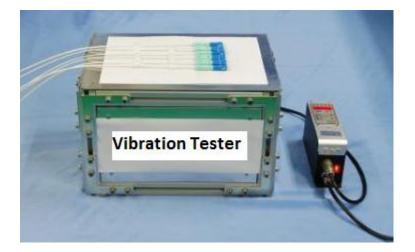
2. Result of Particular Test (c)

Vibration Test (Sine)

- Frequency Range : 10-50Hz
- Sweep frequency : 45 times/mins
- Amplitude : 0.75mm single amplitude
- Duration and Direction : 3 directions,
 2 hour for each

• IL : ≤0.3dB, RL : ≤5dB

- IL : ≤0.05dB, RL : ≤1.3dB
- No mechanical damage, No obvious scratches on ferrules surface

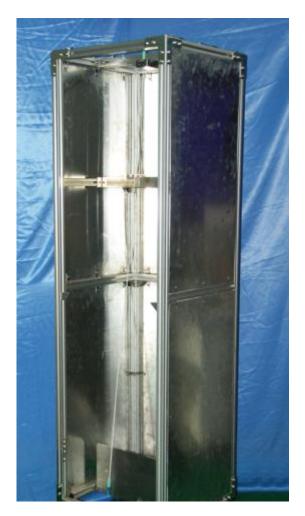
2. Result of Particular Test (d)

Drop Test

- Height : 1.5m above samples head
- Times : 8 times

• IL : ≤0.3dB, RL : ≤5dB

- IL : ≤0.06dB, RL : ≤1.2dB
- No mechanical damage, deformation cracking or relaxing

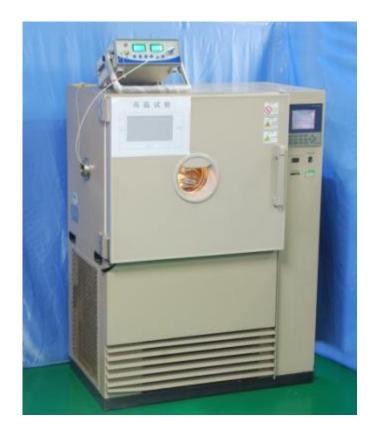
2. Result of Particular Test (e)

High Temperature Test

- Temperature : +85 °C
- Duration : 96h

• IL : ≤0.3dB, RL : ≤5dB

- IL : ≤0.07dB, RL : ≤2.5dB
- No mechanical damage, deformation cracking or relaxing

• IL : ≤0.1dB, RL : ≤3dB

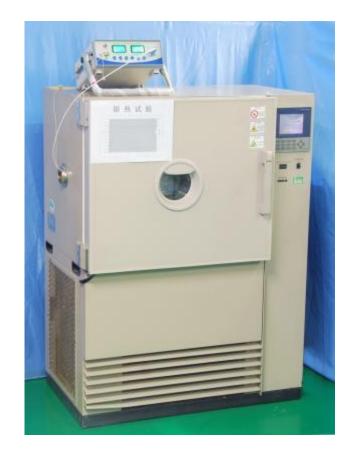
2. Result of Particular Test (f)

Humidity and Hot Test

- Temperature : +75 °C
- Humidity Rate : 95%
- Duration : 96h

• IL : ≤0.3dB, RL : ≤5dB

- IL : ≤0.05dB, RL : ≤1.7dB
- No mechanical damage, deformation cracking or relaxing

• IL : ≤0.1dB, RL : ≤2dB

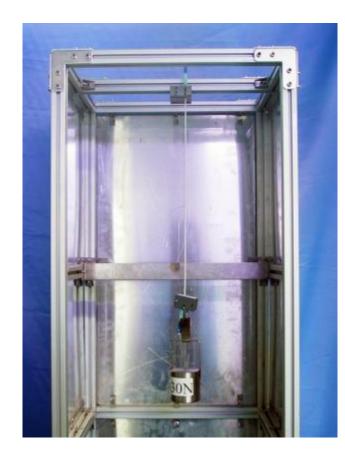
2. Result of Particular Test (g)

Tension Test

- Load : 20N (online test), 30N (offline test)
- Duration : 2 mins
- Distance : 22-28 cm

• IL : ≤0.3dB, RL : ≤5dB

- IL : ≤0.03dB, RL : ≤0.7dB
- No mechanical damage, deformation cracking or relaxing

• IL : ≤0.03dB, RL : ≤0.7dB

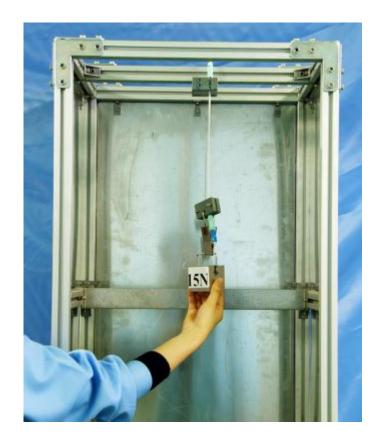
2. Result of Particular Test (h)

Torsion Test

- Load : 15N
- Distance : 22-28 cm
- Times : 200 times
- Pulling Frequency : 10 times/ mins

• IL : ≤0.3dB, RL : ≤5dB

- IL : ≤0.02dB, RL : ≤0.4dB
- No mechanical damage, deformation cracking or relaxing

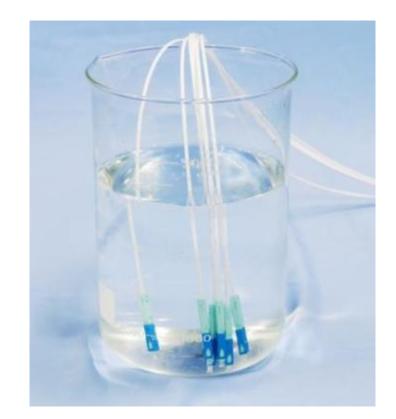
2. Result of Particular Test (i)

Ingress Protection Test

- Container Environments:
 25+2°C running water
- Duration : 168 hrs

• IL : ≤0.3dB, RL : ≤5dB

- IL : ≤0.09dB, RL : ≤1.4dB
- No mechanical damage, deformation cracking or relaxing
